# Why is the Shaky Bridge so Shaky?

**Deirdre O'Donnell**

Civil and Environmental Engineering, School of Engineering, UCC

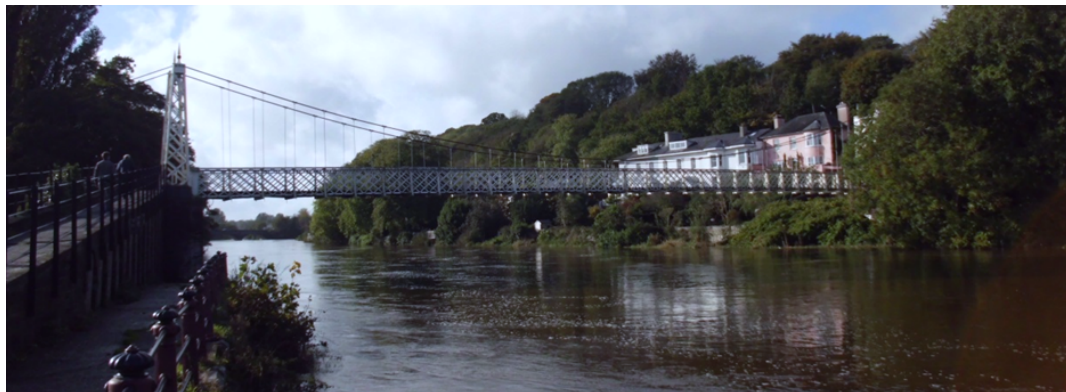
There are only three suspension bridges in Ireland; at Birr and Kinnitty Castles, both in Co. Offaly, and Cork's own Daly's Bridge. The 87m meter long steel suspension bridge spans the River Lee, shown in Figure 1, connecting the Mardyke and Sunday's Well areas just east of Cork city centre. Constructed in 1926 to replace a ferry crossing at the location, it was manufactured by David Rowell & Co. Ltd. of London to the specifications of then Cork City engineer Stephen William Farrington. Named Daly's Bridge for James Daly, a wealthy benefactor of the project, today it is better known locally as 'The Shaky Bridge' for its perceived 'shakiness'.

Figure 1: Daly's Bridge, River Lee, Cork. Source: Author

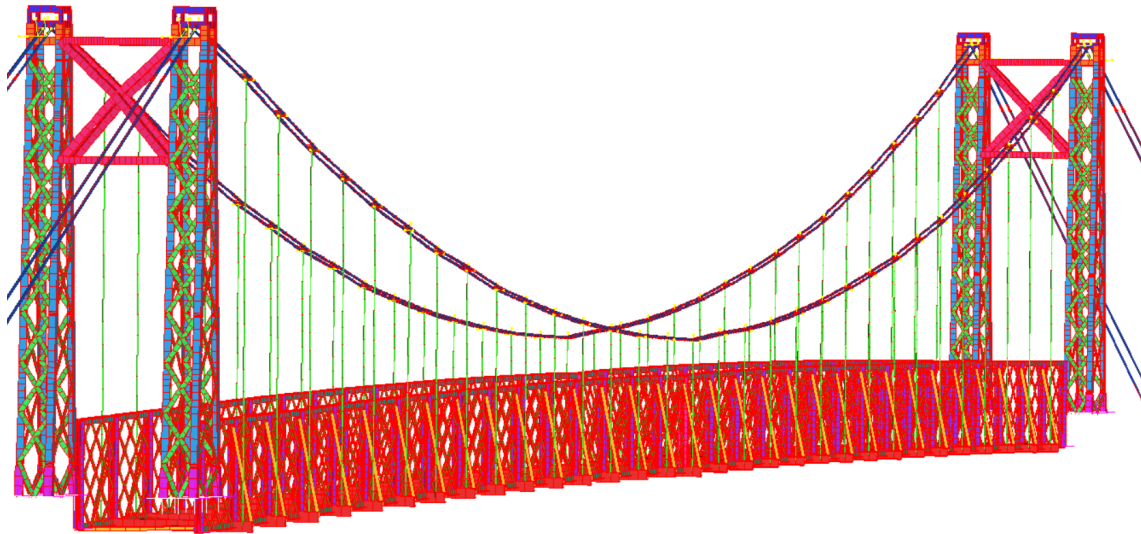
In order to assess the vibration characteristics of the structure a finite element model was then constructed (Figure 4). This computer model was created using Strand 7 software, and it is a full geometric representation of the bridge, with each member assigned the appropriate material properties of steel and the connections between members were designed to represent the real, physical connections on the bridge. The damaged members, identified in the visual inspection, which included some members of the handrails and towers, were removed from the model for a more realistic representation. Changes were also made to the properties of steel used, in order to match the results of the model to the results from the testing of the as-built condition of the bridge, discussed below.

Figure 2: Detailed finite element model of Daly's Bridge. Source: Author

Finally, the matching of outputs of the finite element model to the actual responses of the bridge recorded during experimentation lead to a more realistic representation of the structure in its true condition. This matching is an important part of many structural health monitoring applications, as an accurate computer model can be used as a base line for assess future changes in the bridge, and assess the effect such damage might have on the structure, globally.
